Project 204098.06  
11 September 2024  
R.002.Rev0  
NG

## **Report on Dewatering and Desilting of Existing Dam Proposed Commercial Development 253 - 267 Aldington Road, Kemps Creek NSW**

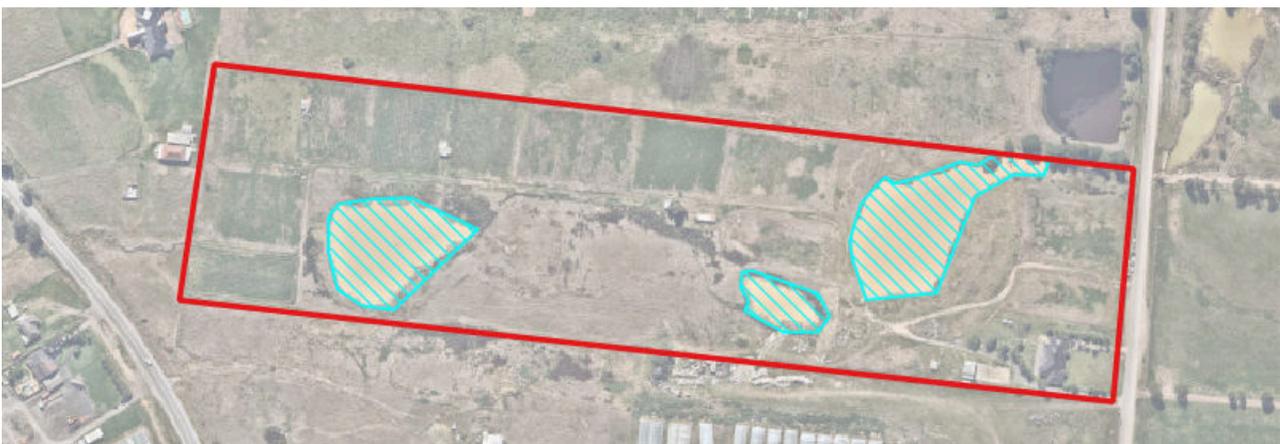
**Figure 1 – Existing dams within the site**

The site boundary is shown in red, and the dam locations are shown in blue on the aerial photo in Figure 1.
