ErSed Reference: 25024-ERMR-05-260407

**Re: SSD 23480429 – Westgate Industrial Estate at 253-267 Aldington Road, Kemps Creek**

**Environmental Representative: Monthly Report (ERMR #05)**

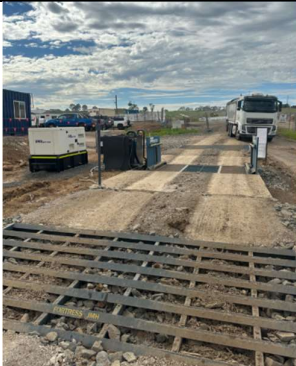
Main Access gate – 26/03/2026

Site access appeared well stabilised during the inspection with vehicles utilising the nominated egress point. No wheel tracking observed.

**OBSERVATION**

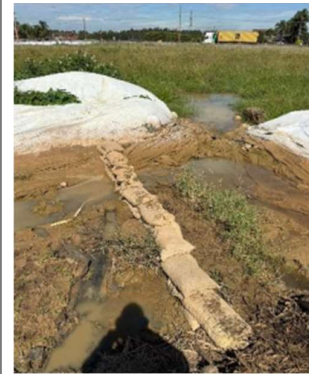
Southern Boundary – 26/03/2026

Areas along the southern boundary previously disturbed during construction of the basin are now well stabilised, with additional catch drains diverting runoff into the basin for treatment.

**OBSERVATION**
